**Photographs of a Visit to Kashmir
(25 – 26 December 2006)**

**for the
RDPI Project**

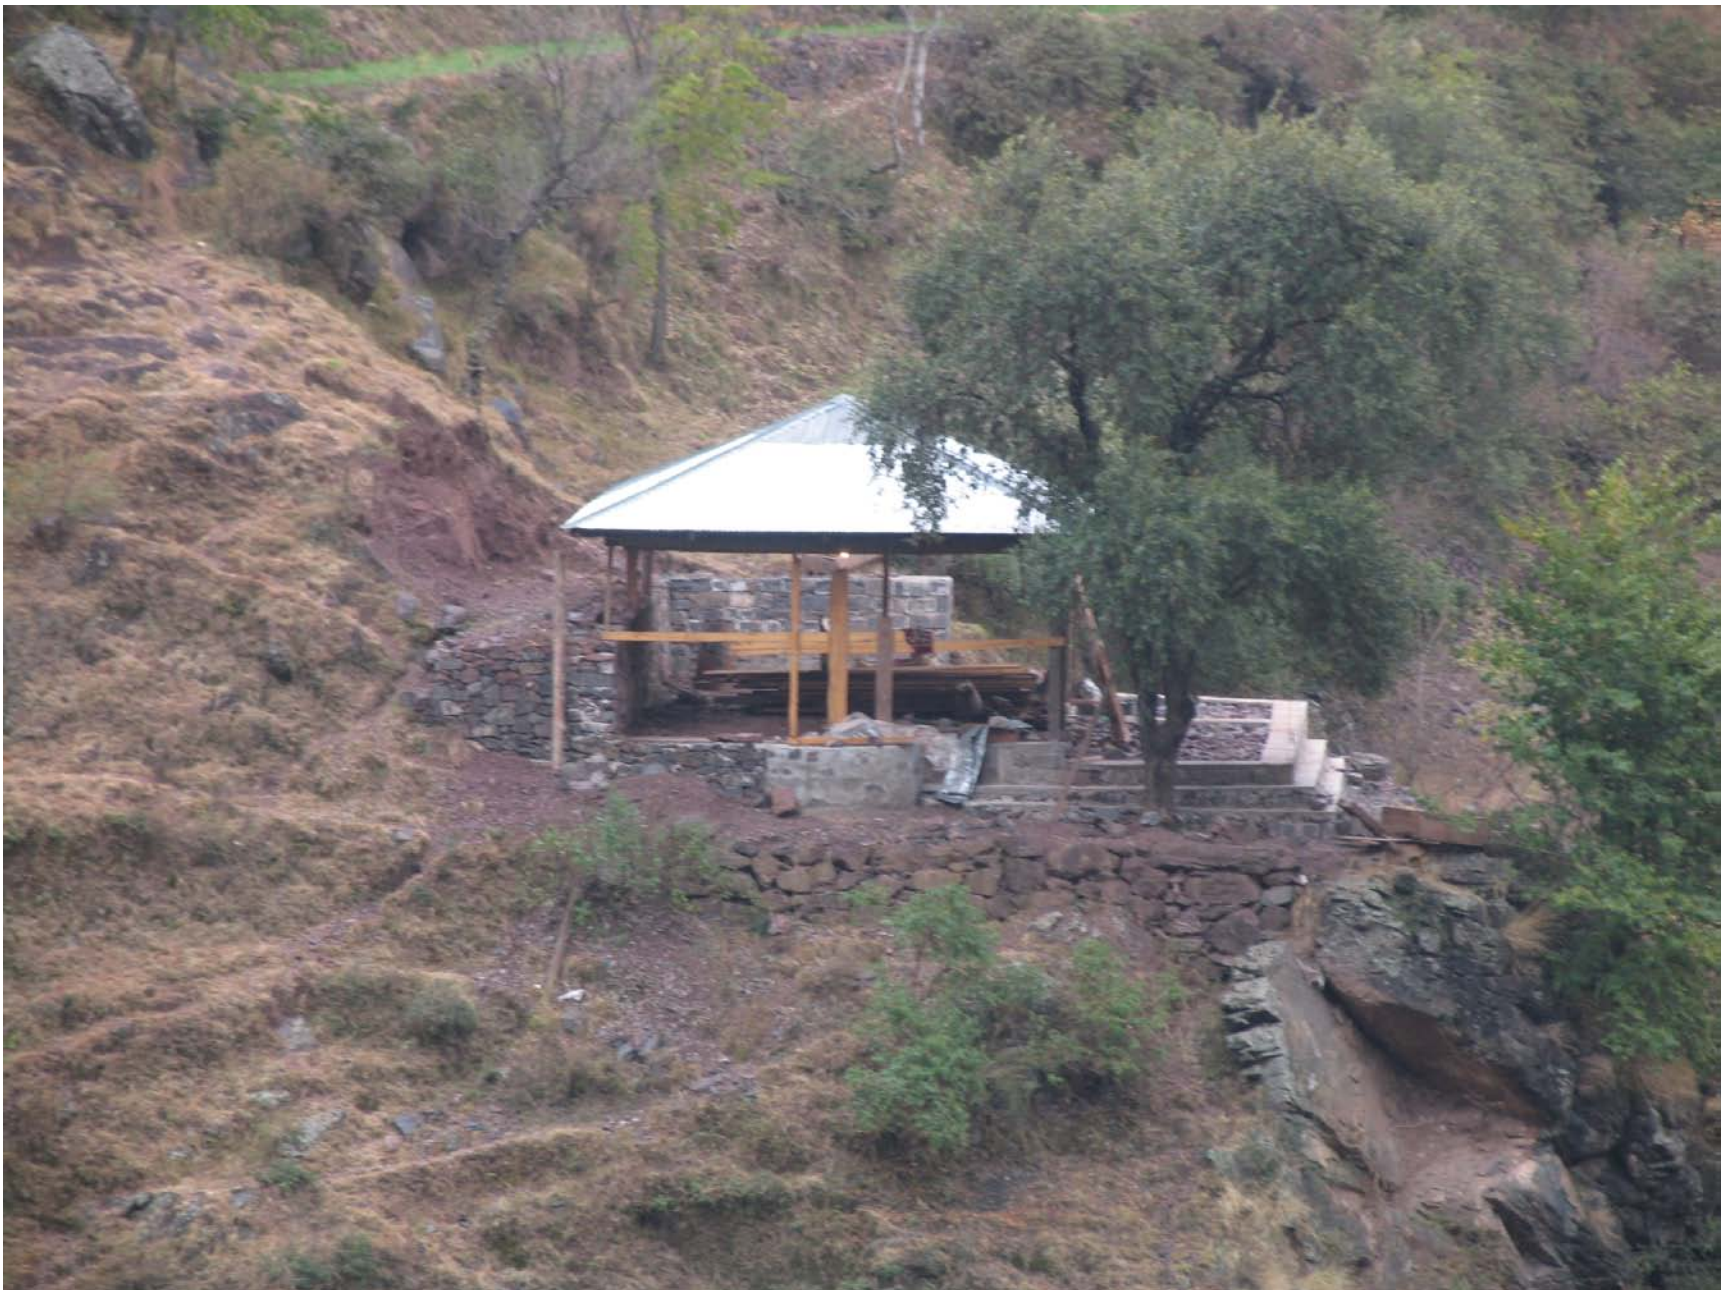
Typical post-earthquake house construction: timber frame, tin roof with concrete block and/or GI sheet walls

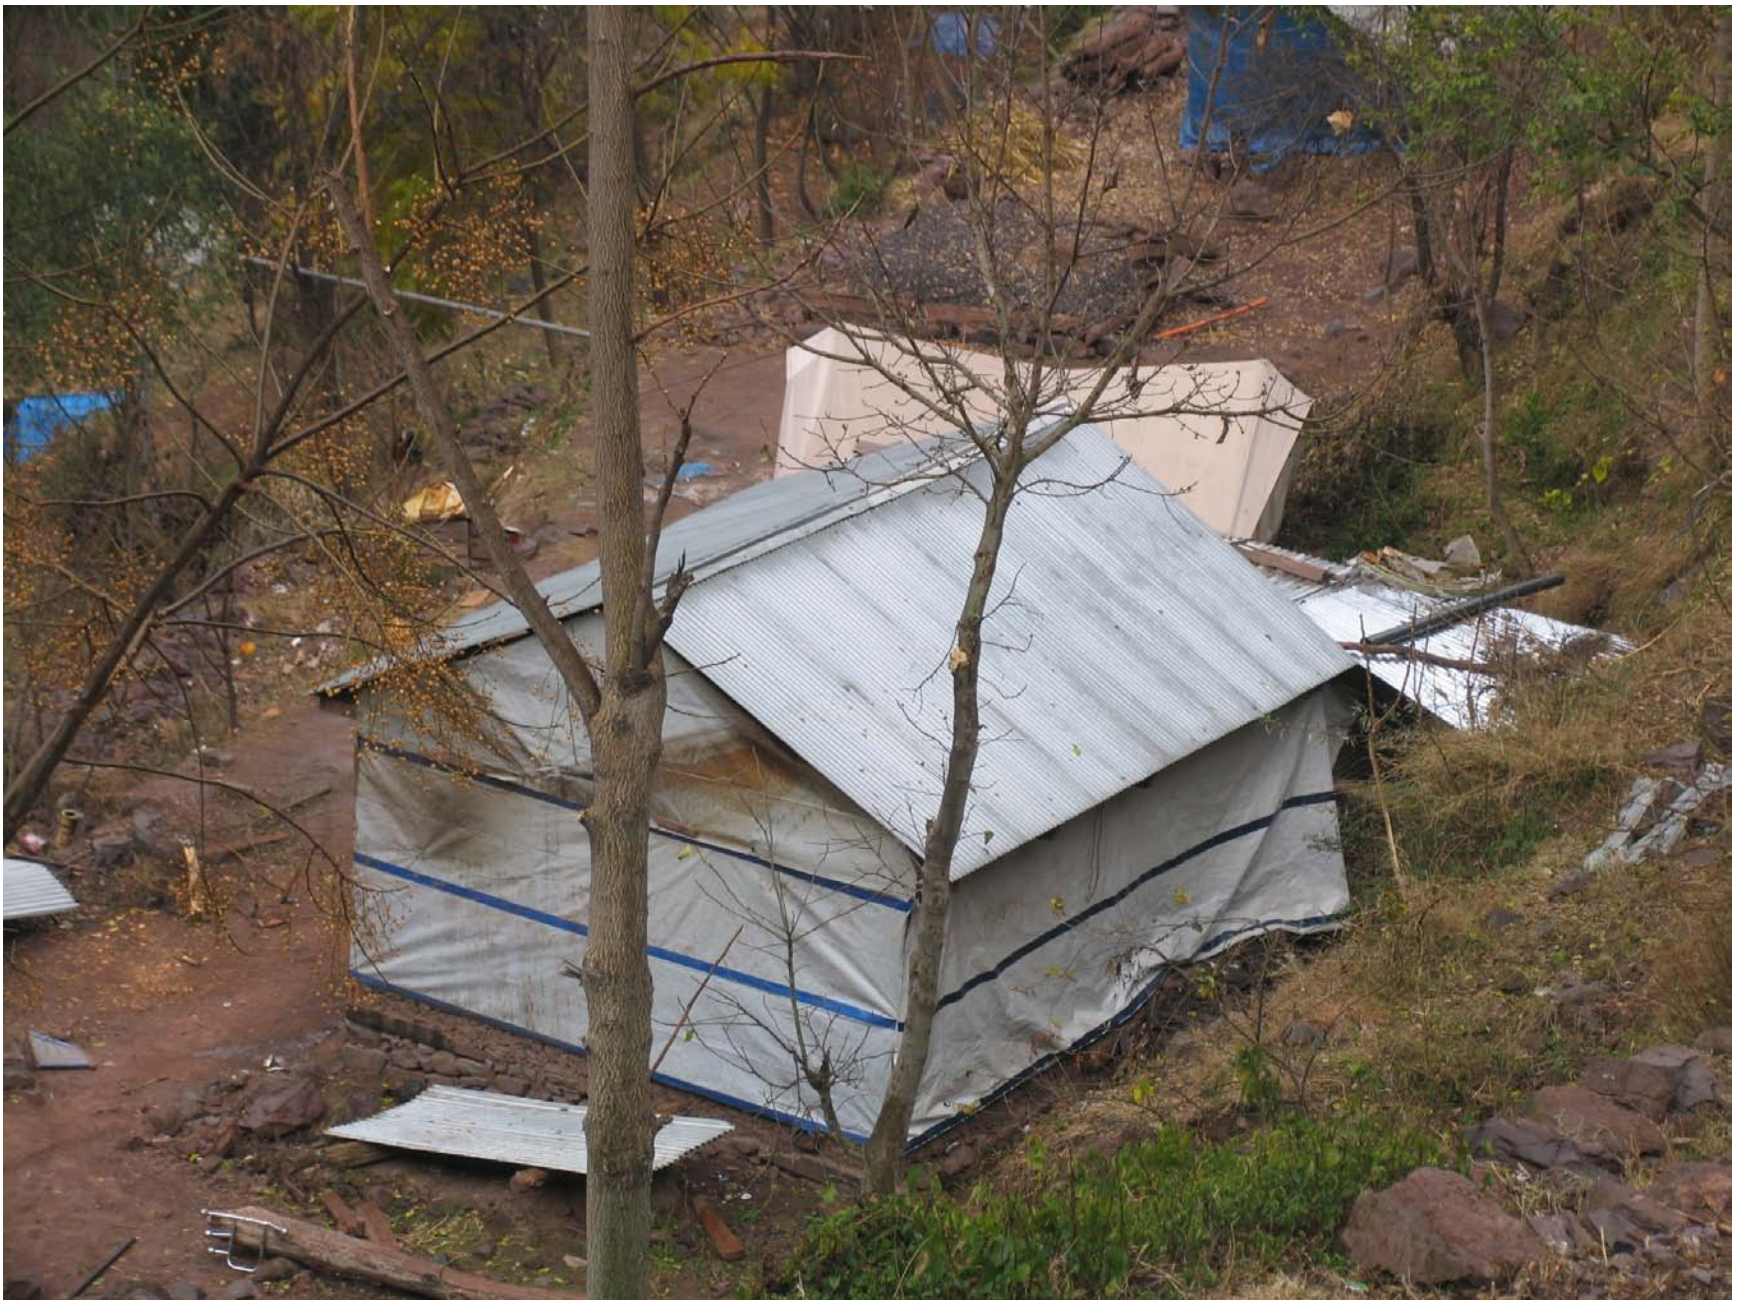
Post-earthquake construction: Plastic sheets used as walls

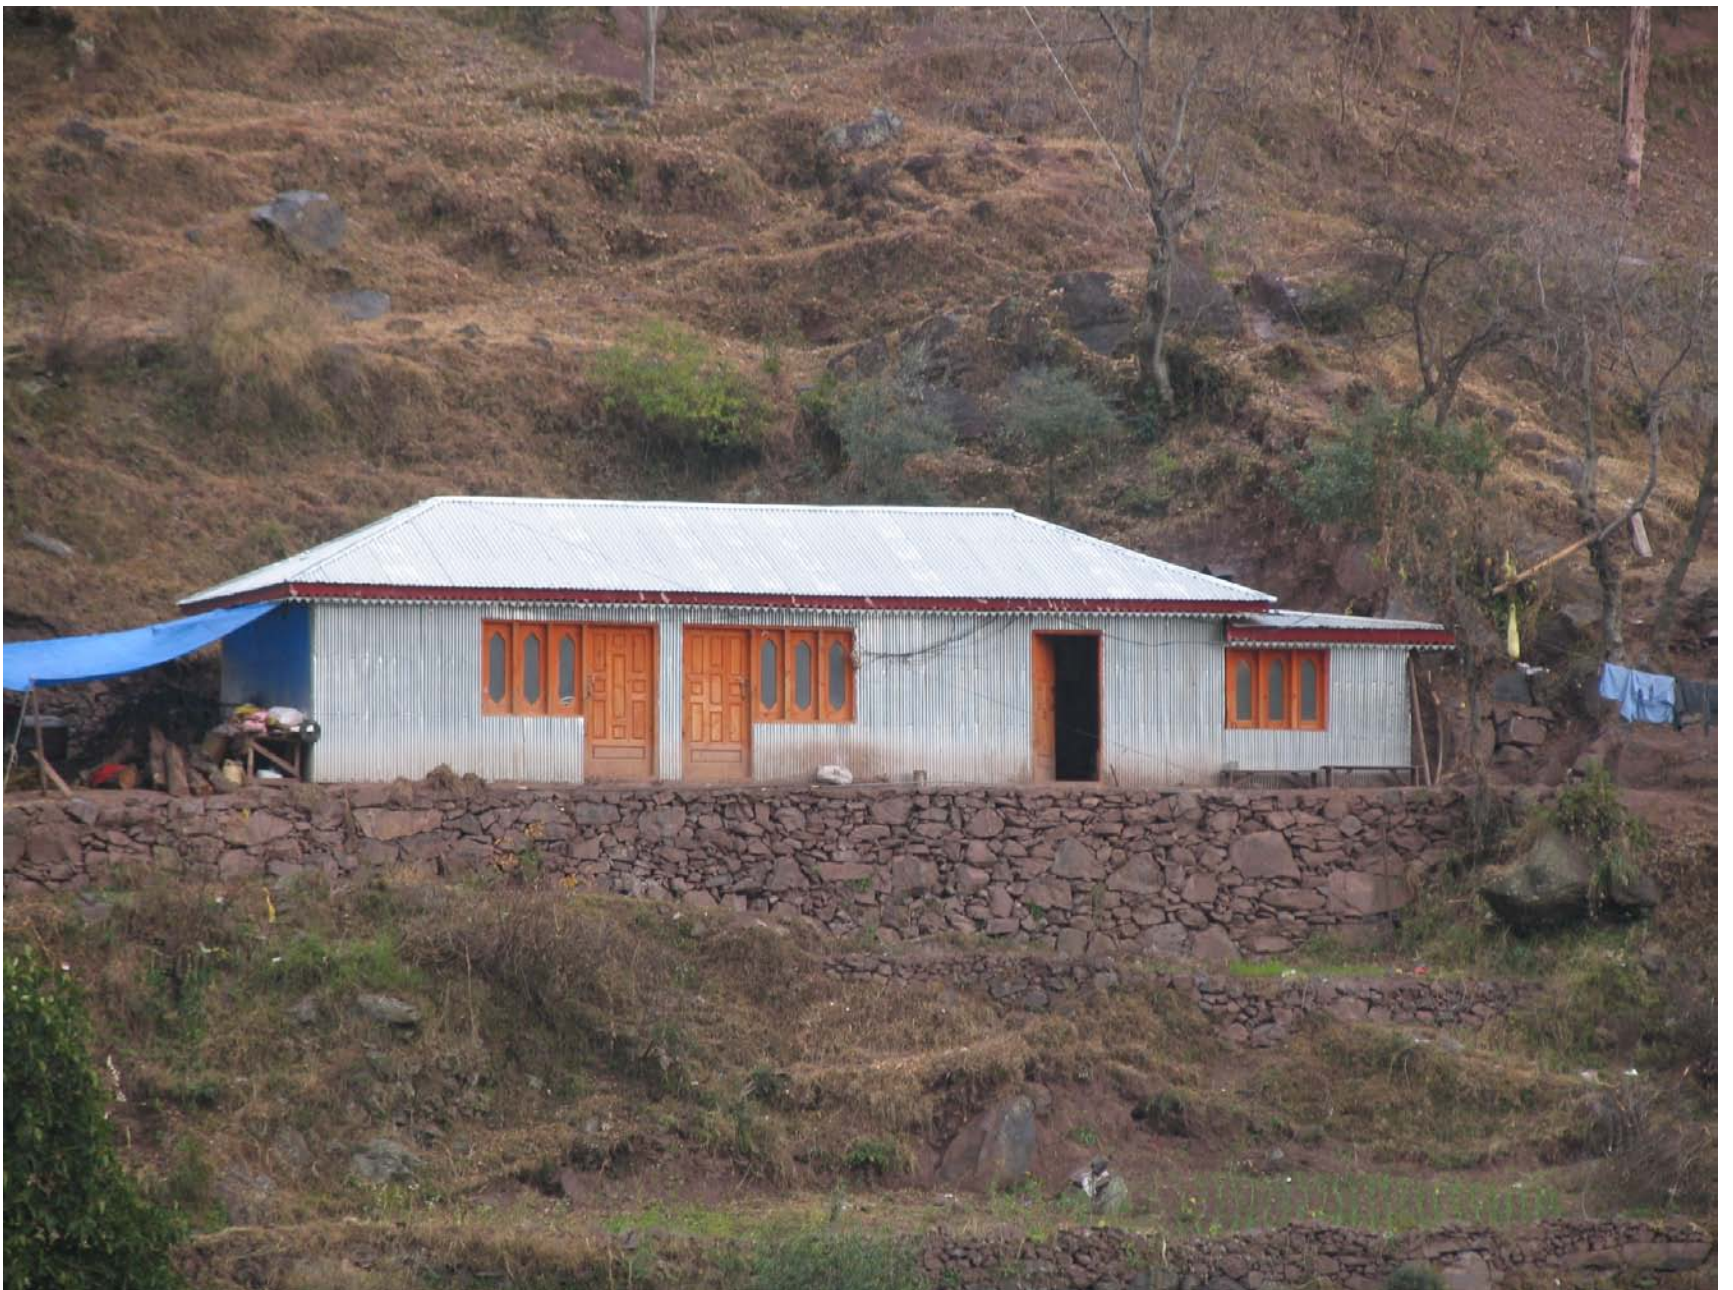
Post-earthquake construction: GI sheet house

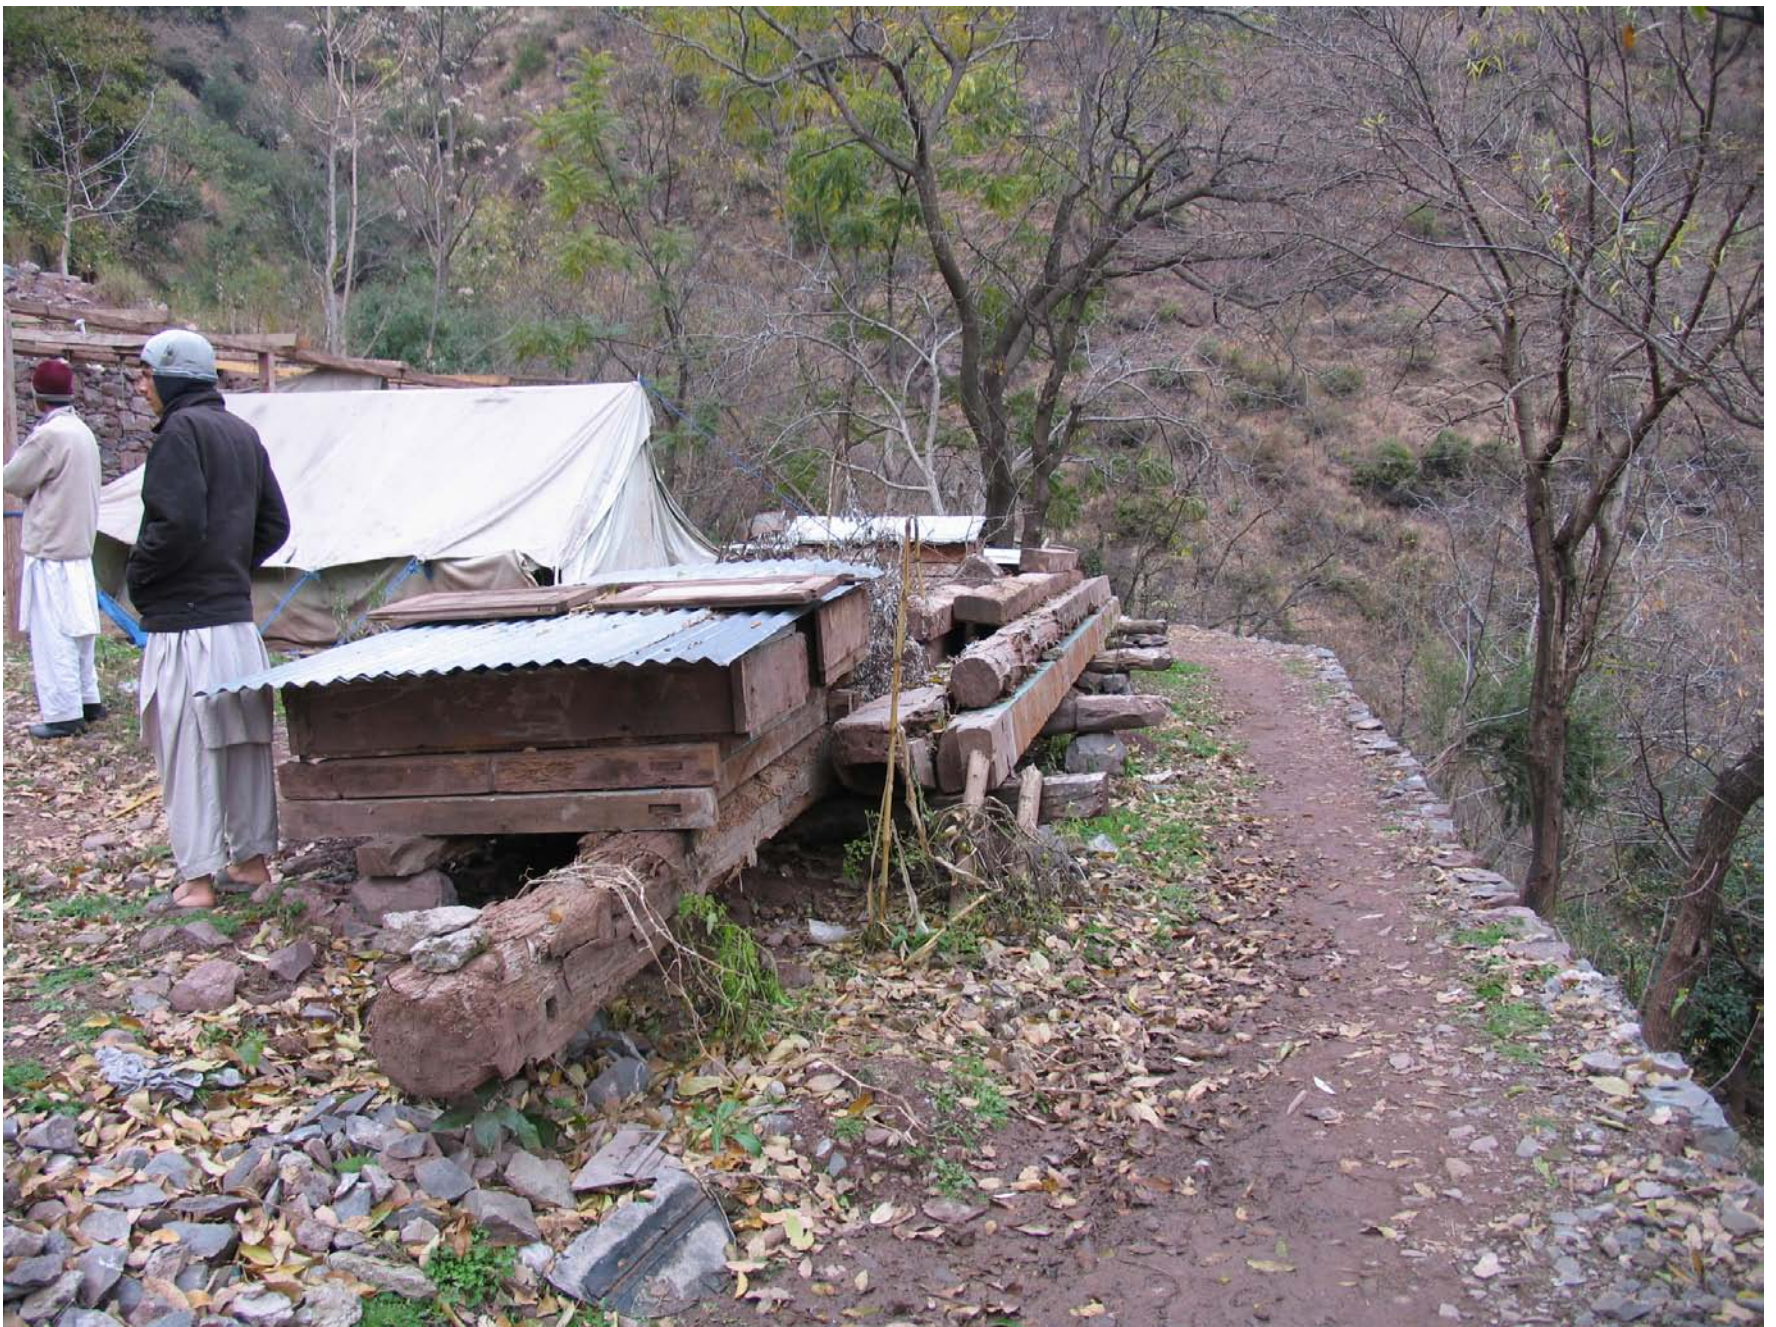
House – 1: Considerable timber salvaged from the old collapsed buildings

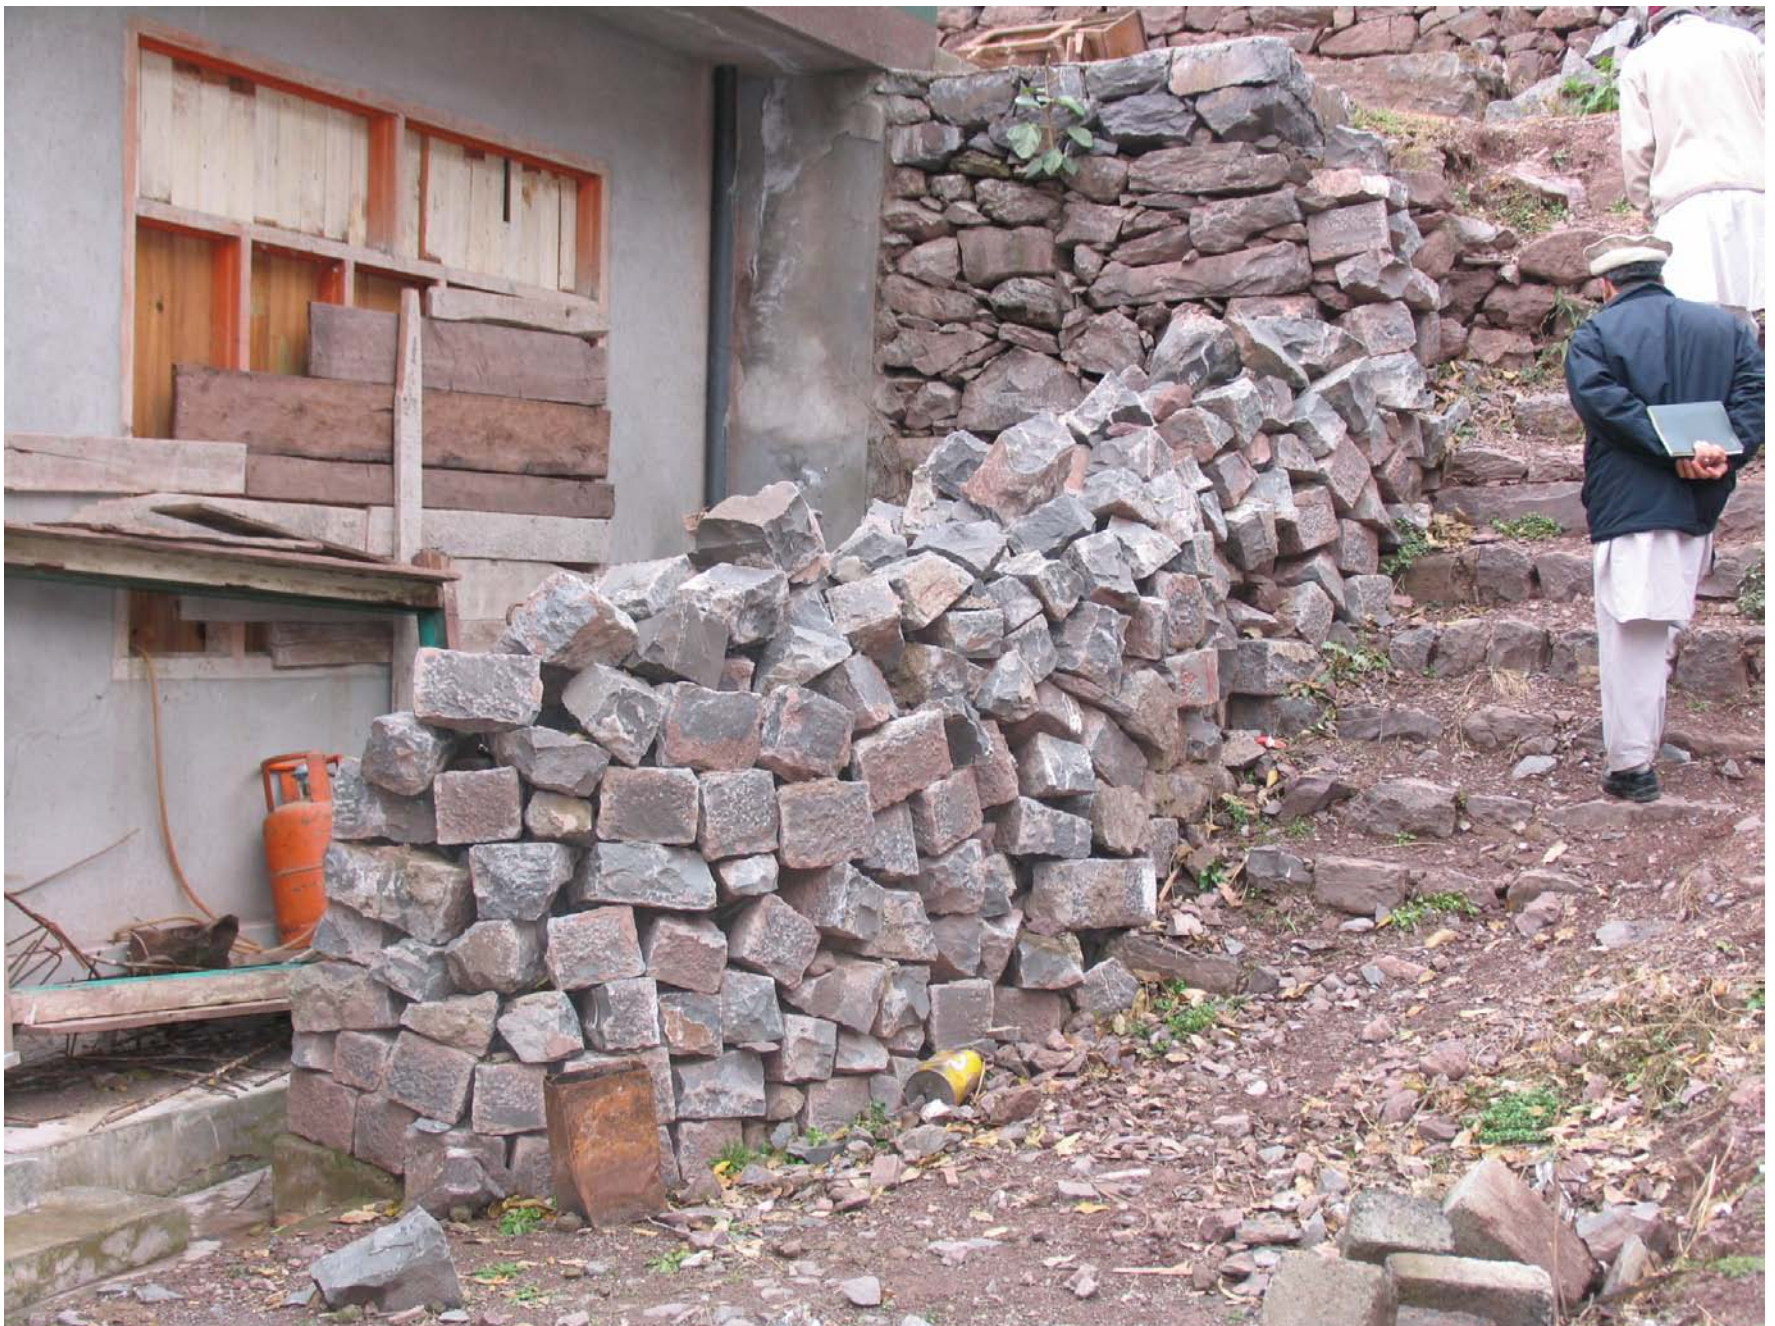
House – 1: Stone rubble from collapsed buildings and terraces

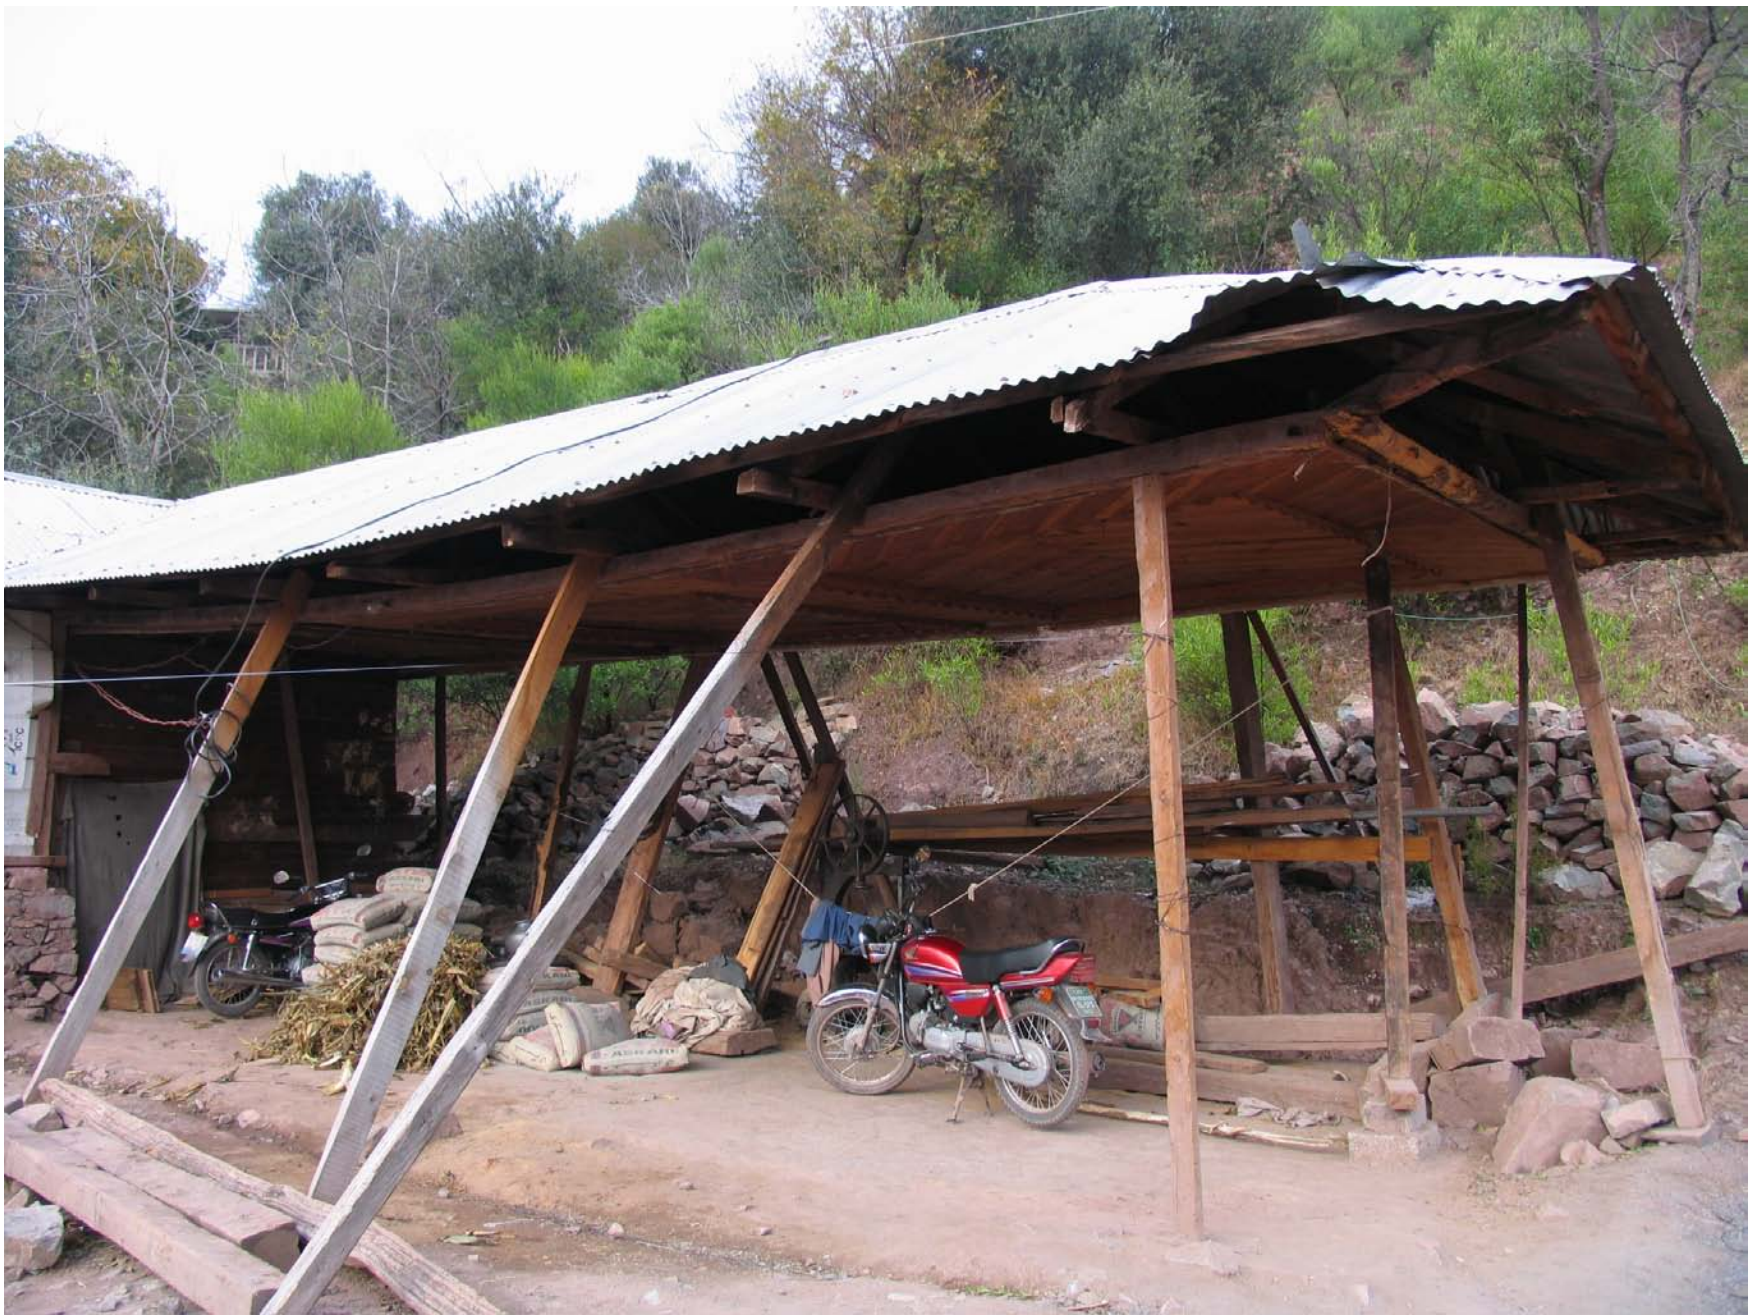
House – 2: The walls collapsed but the roof remained partially intact

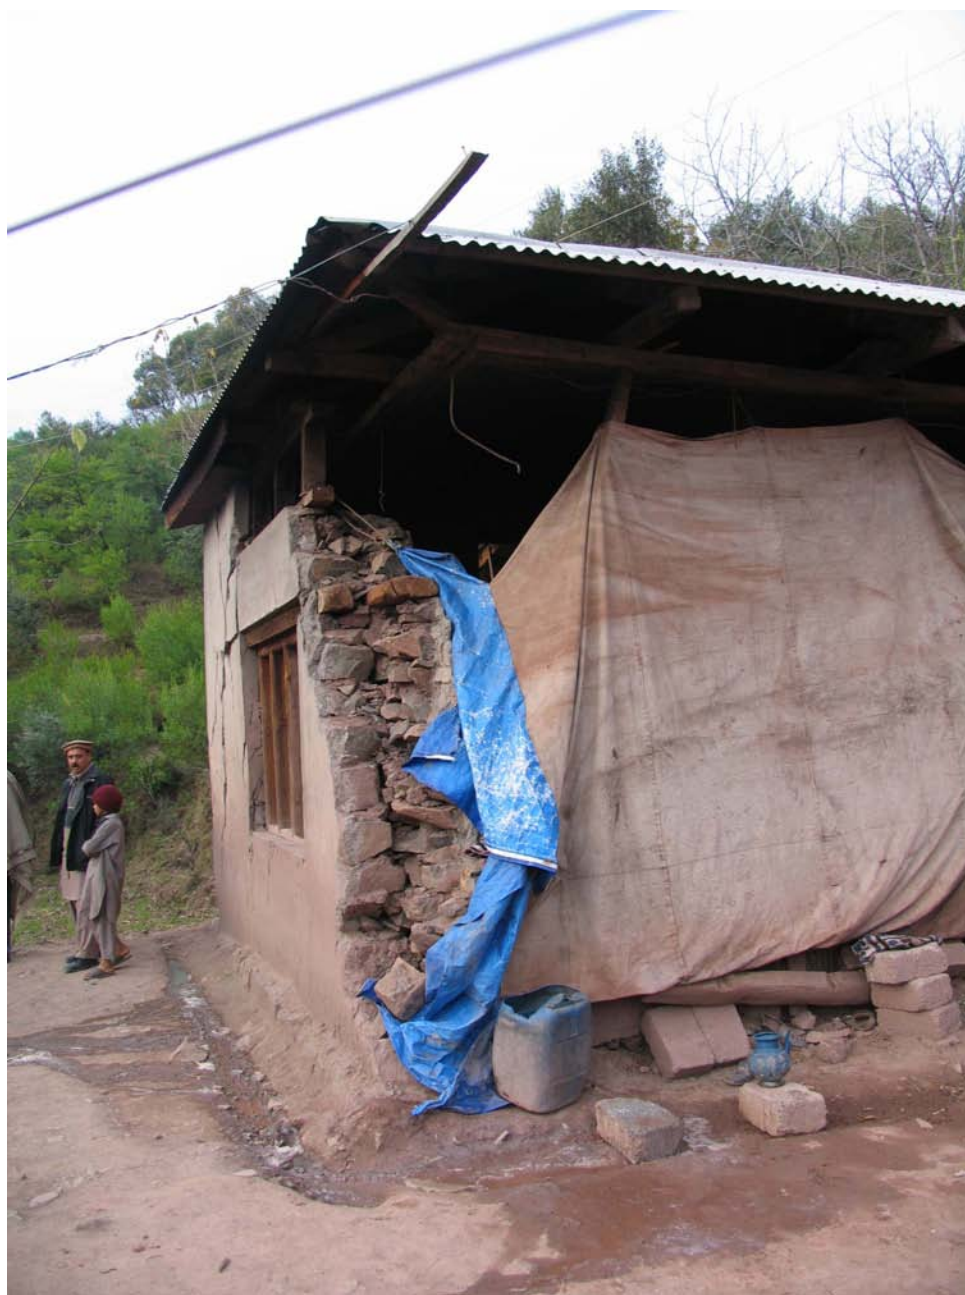
House – 2: Wall construction of the only surviving room

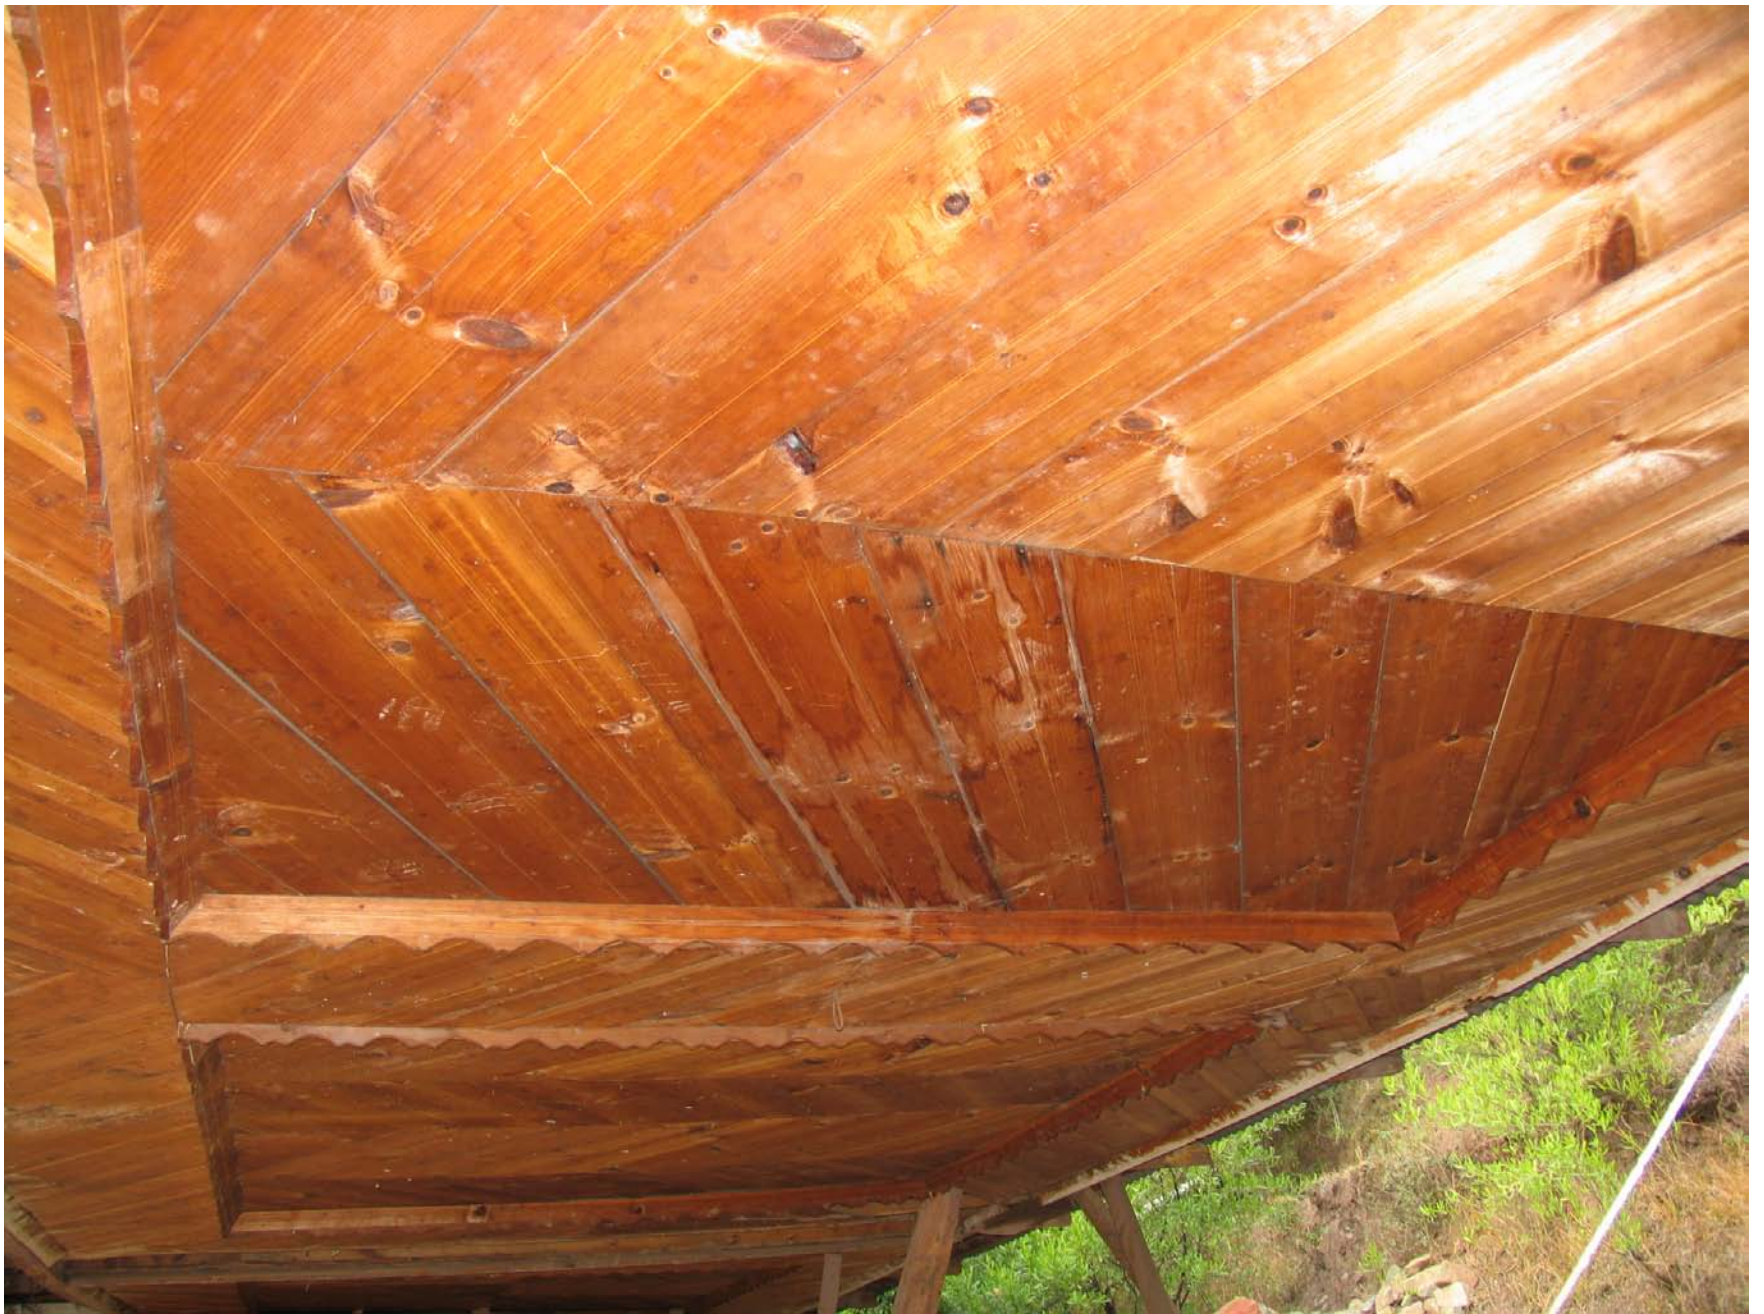
House – 2: Ceiling of the collapsed portion of the house

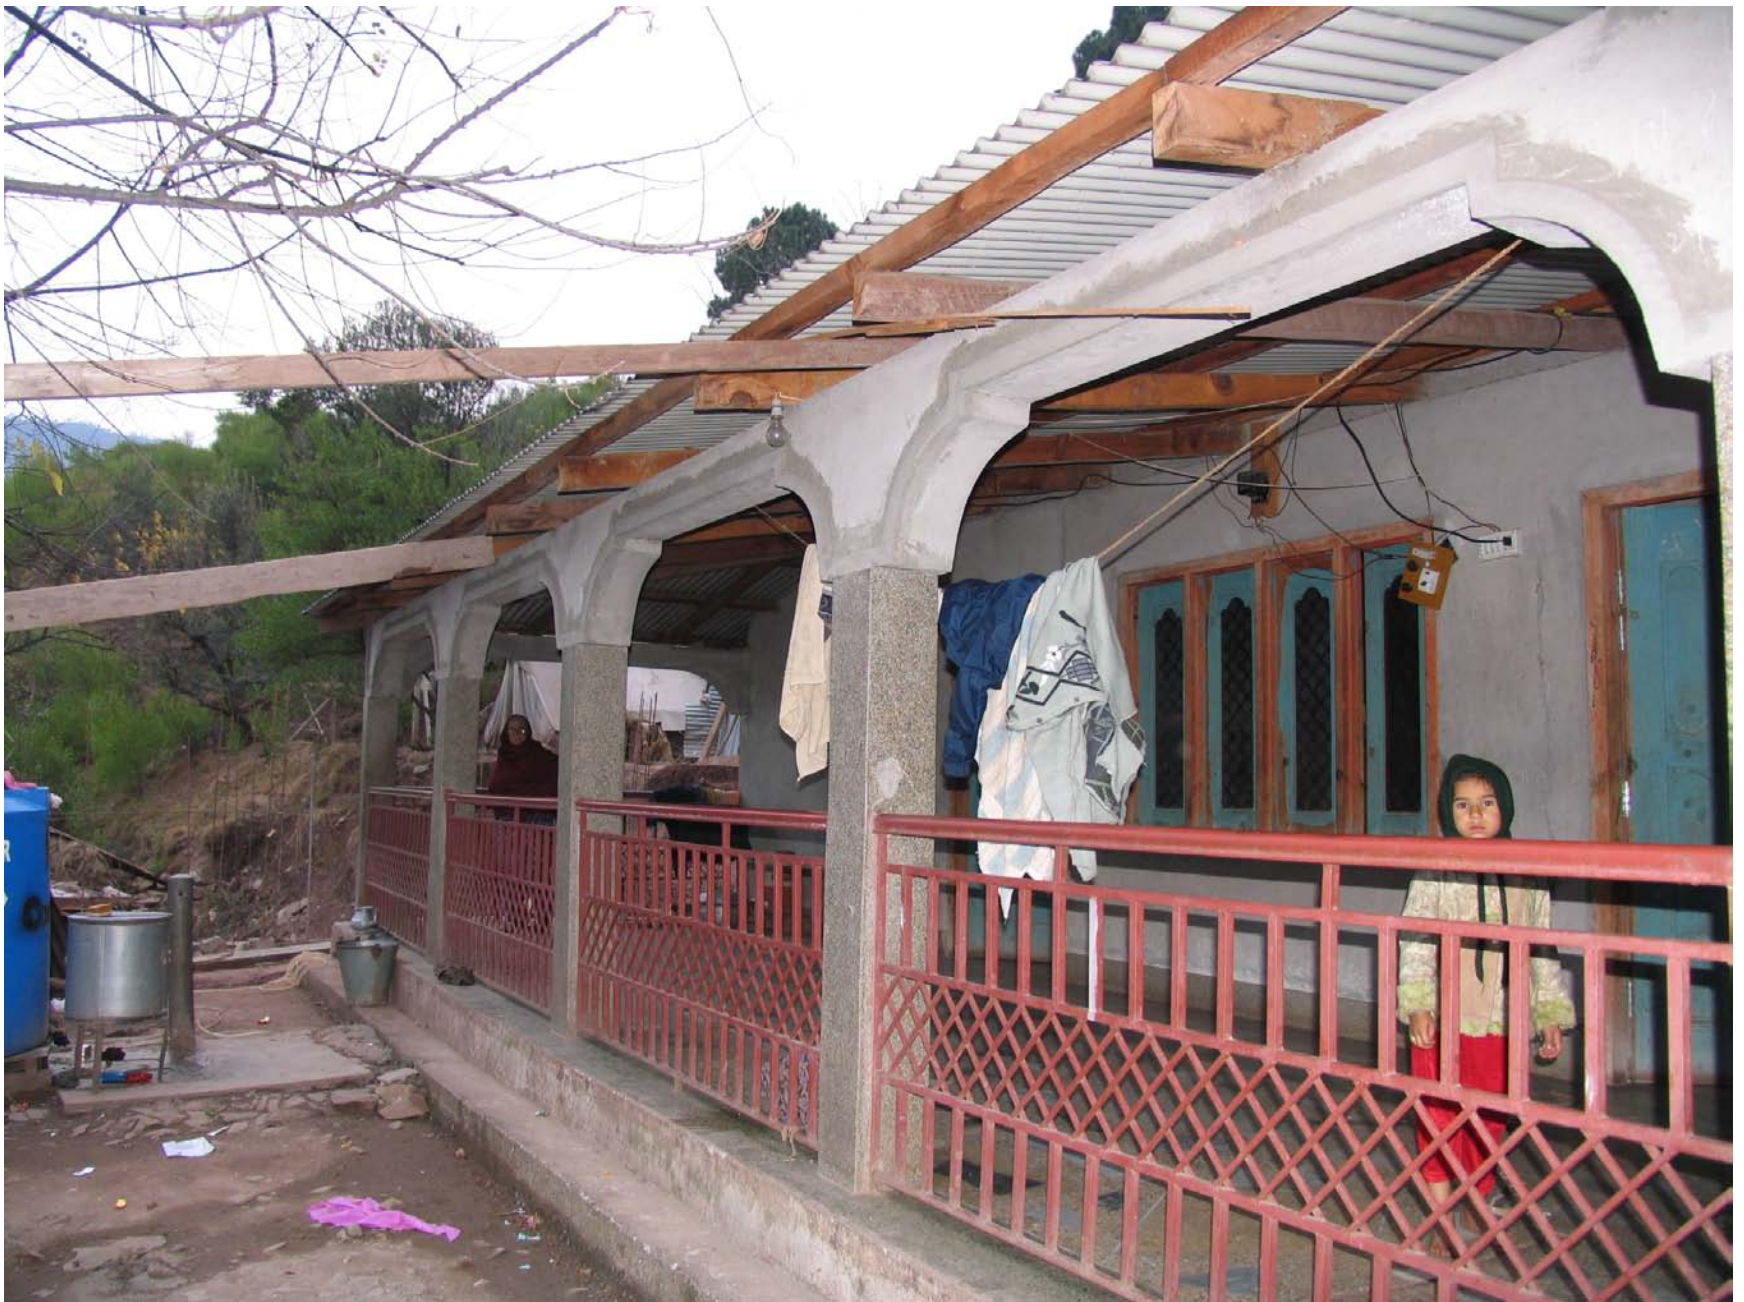
House – 4: An RC construction that survive the earthquake

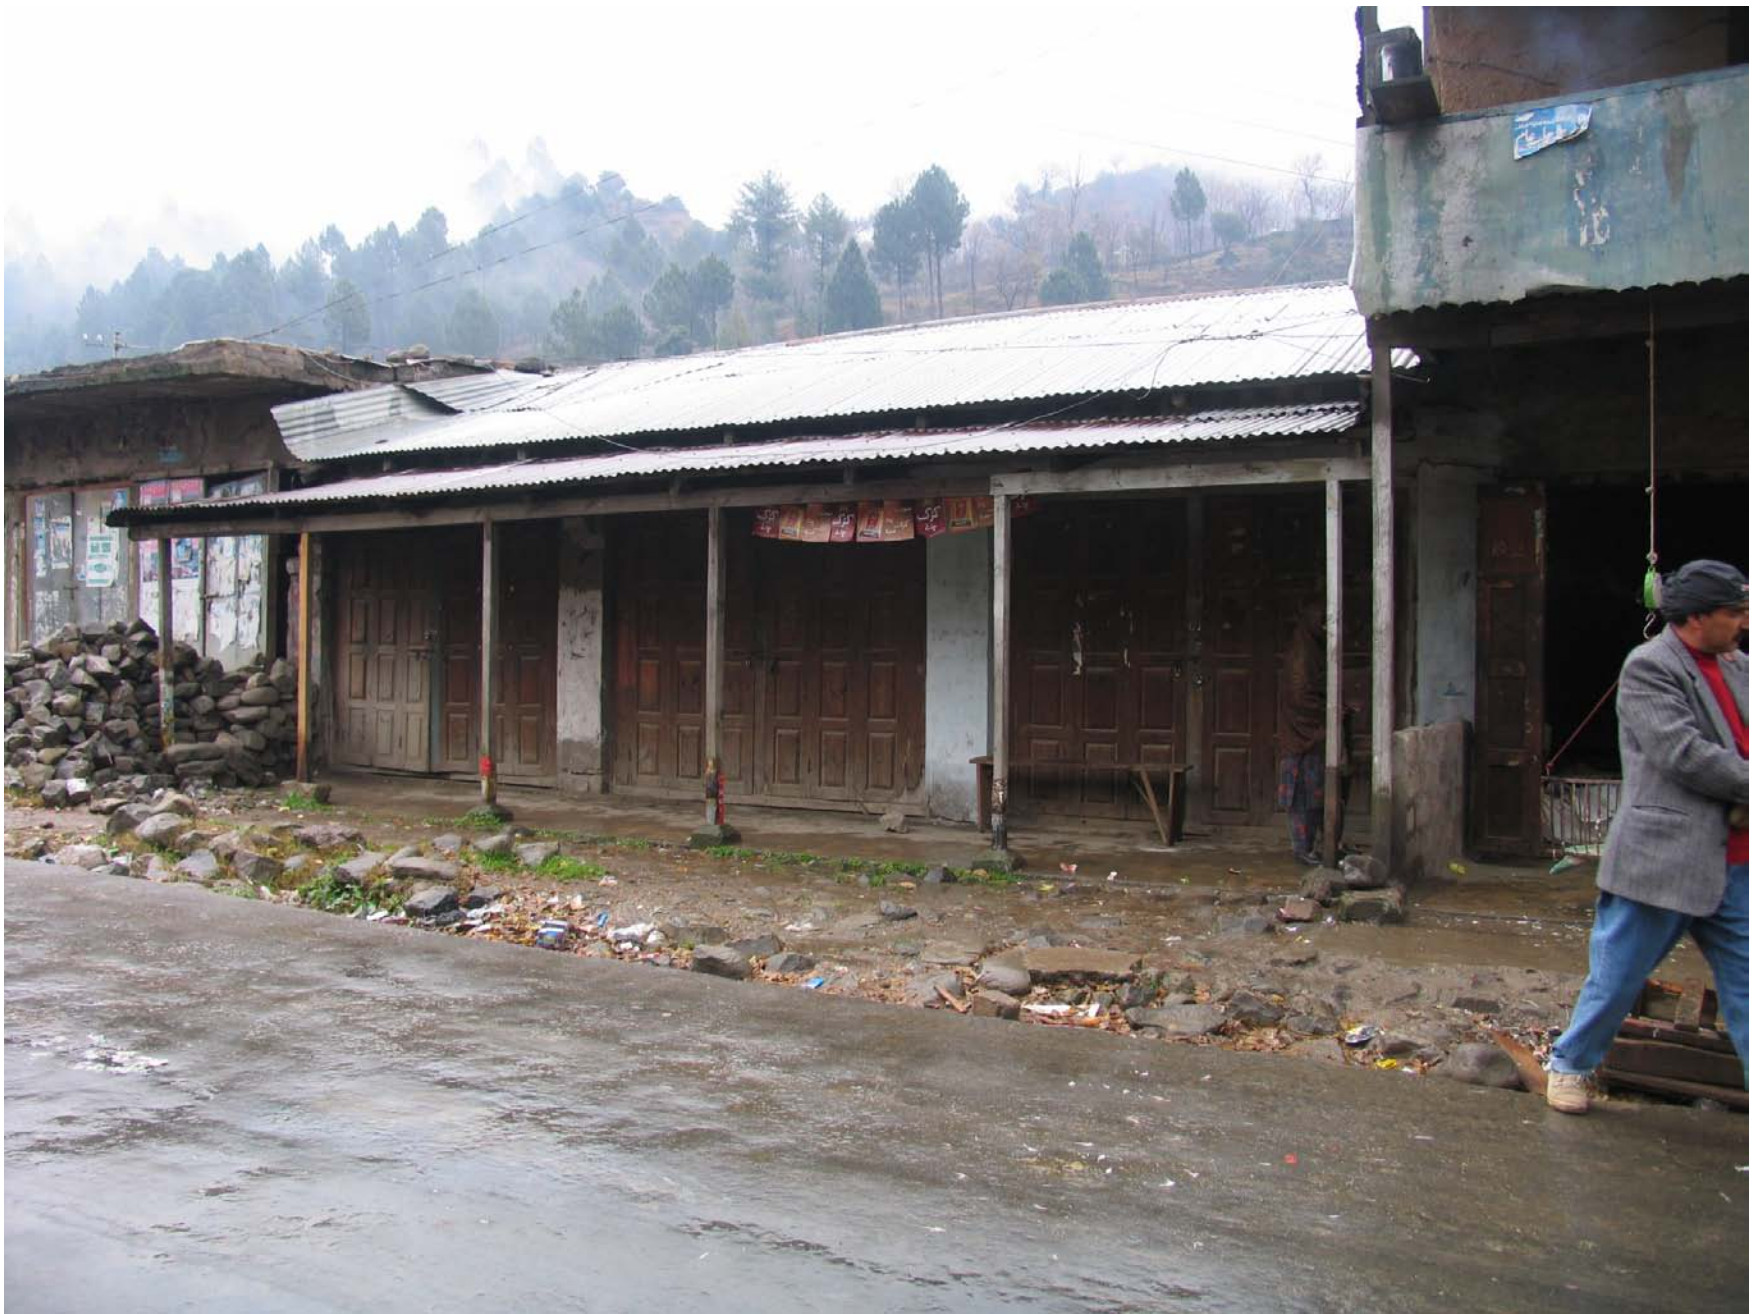
A building near Bagh that did not fall
