**Photographs of a Visit to Kashmir
(25 – 26 December 2006)**

**for the
RDPI Project**

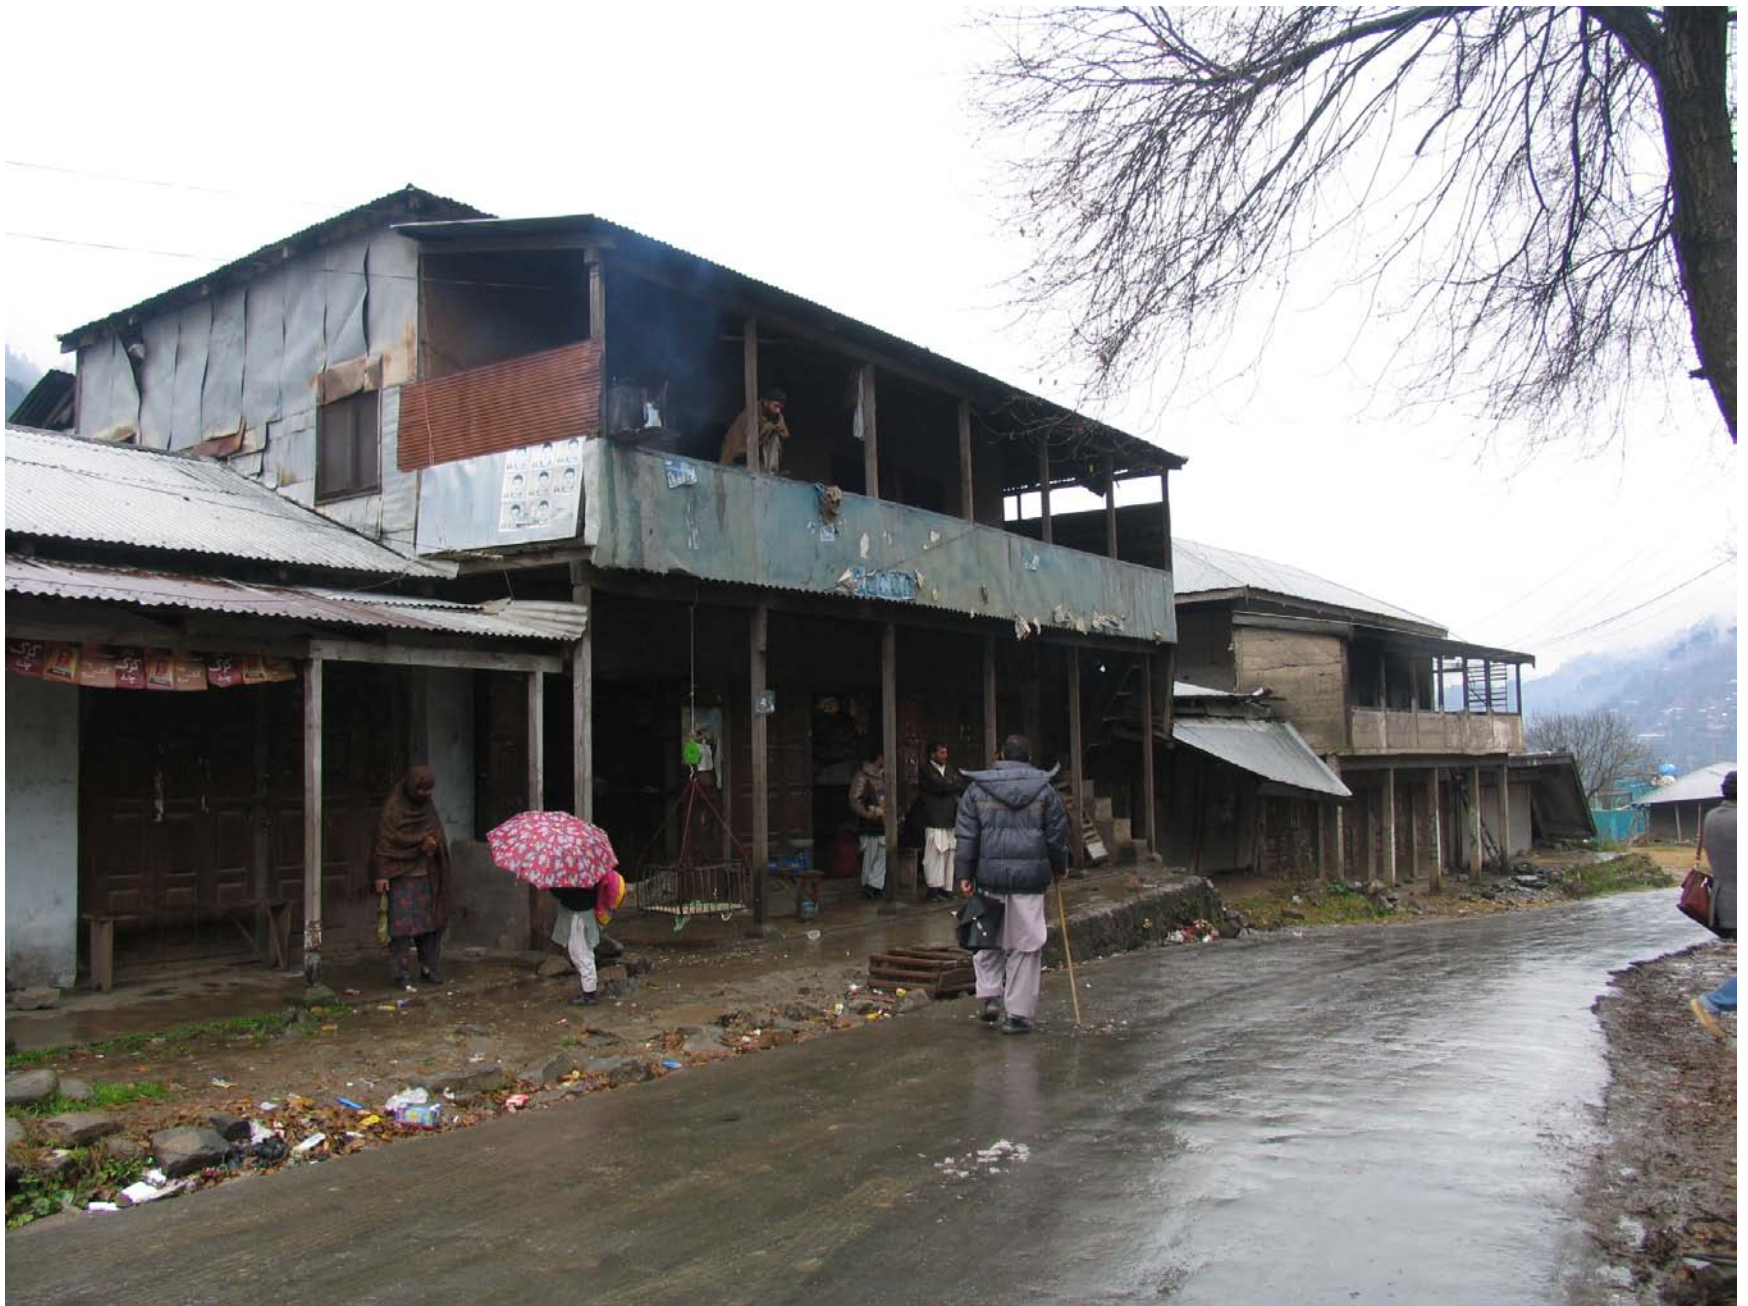
A two storey building that did not fall

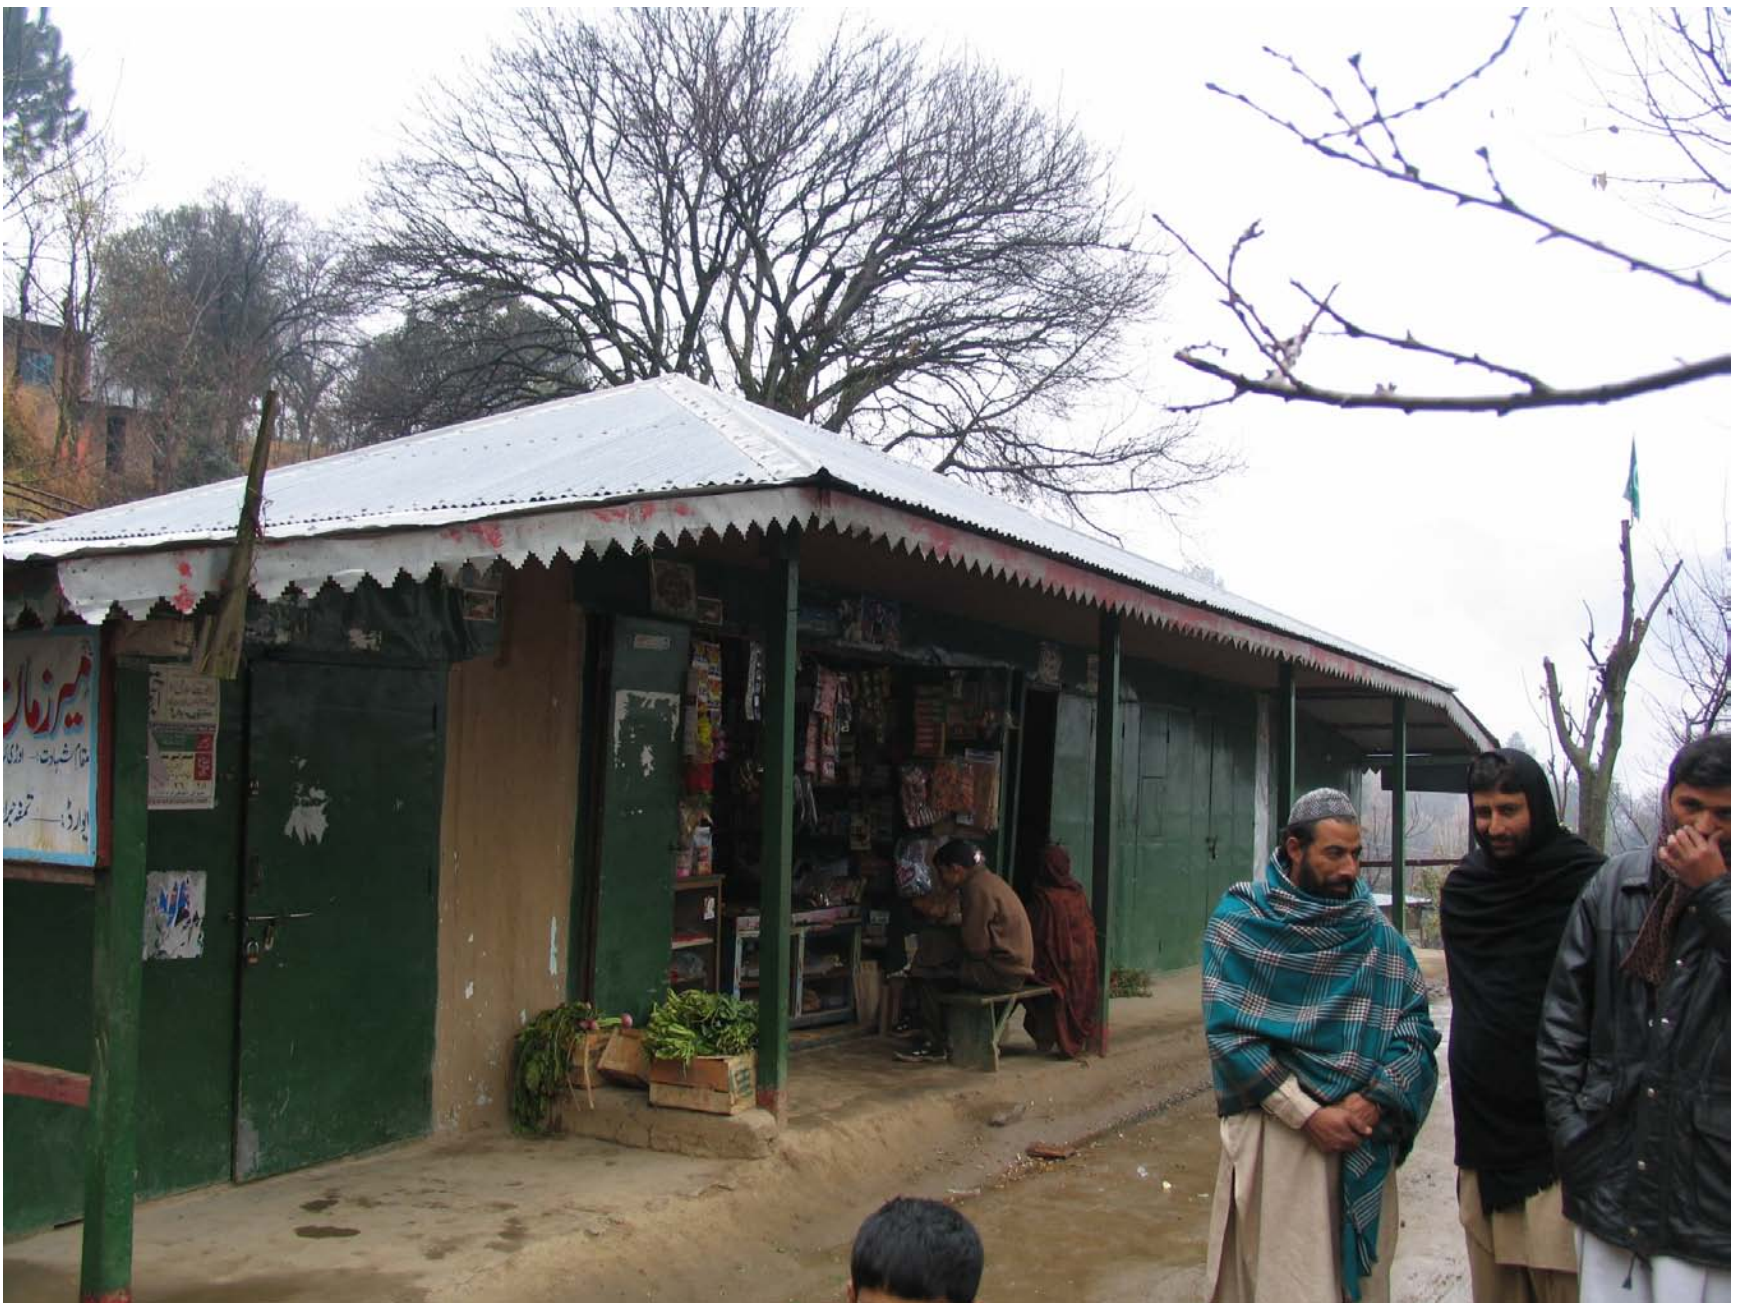
Another building whose structure did not collapse but the stone walls were badly damaged

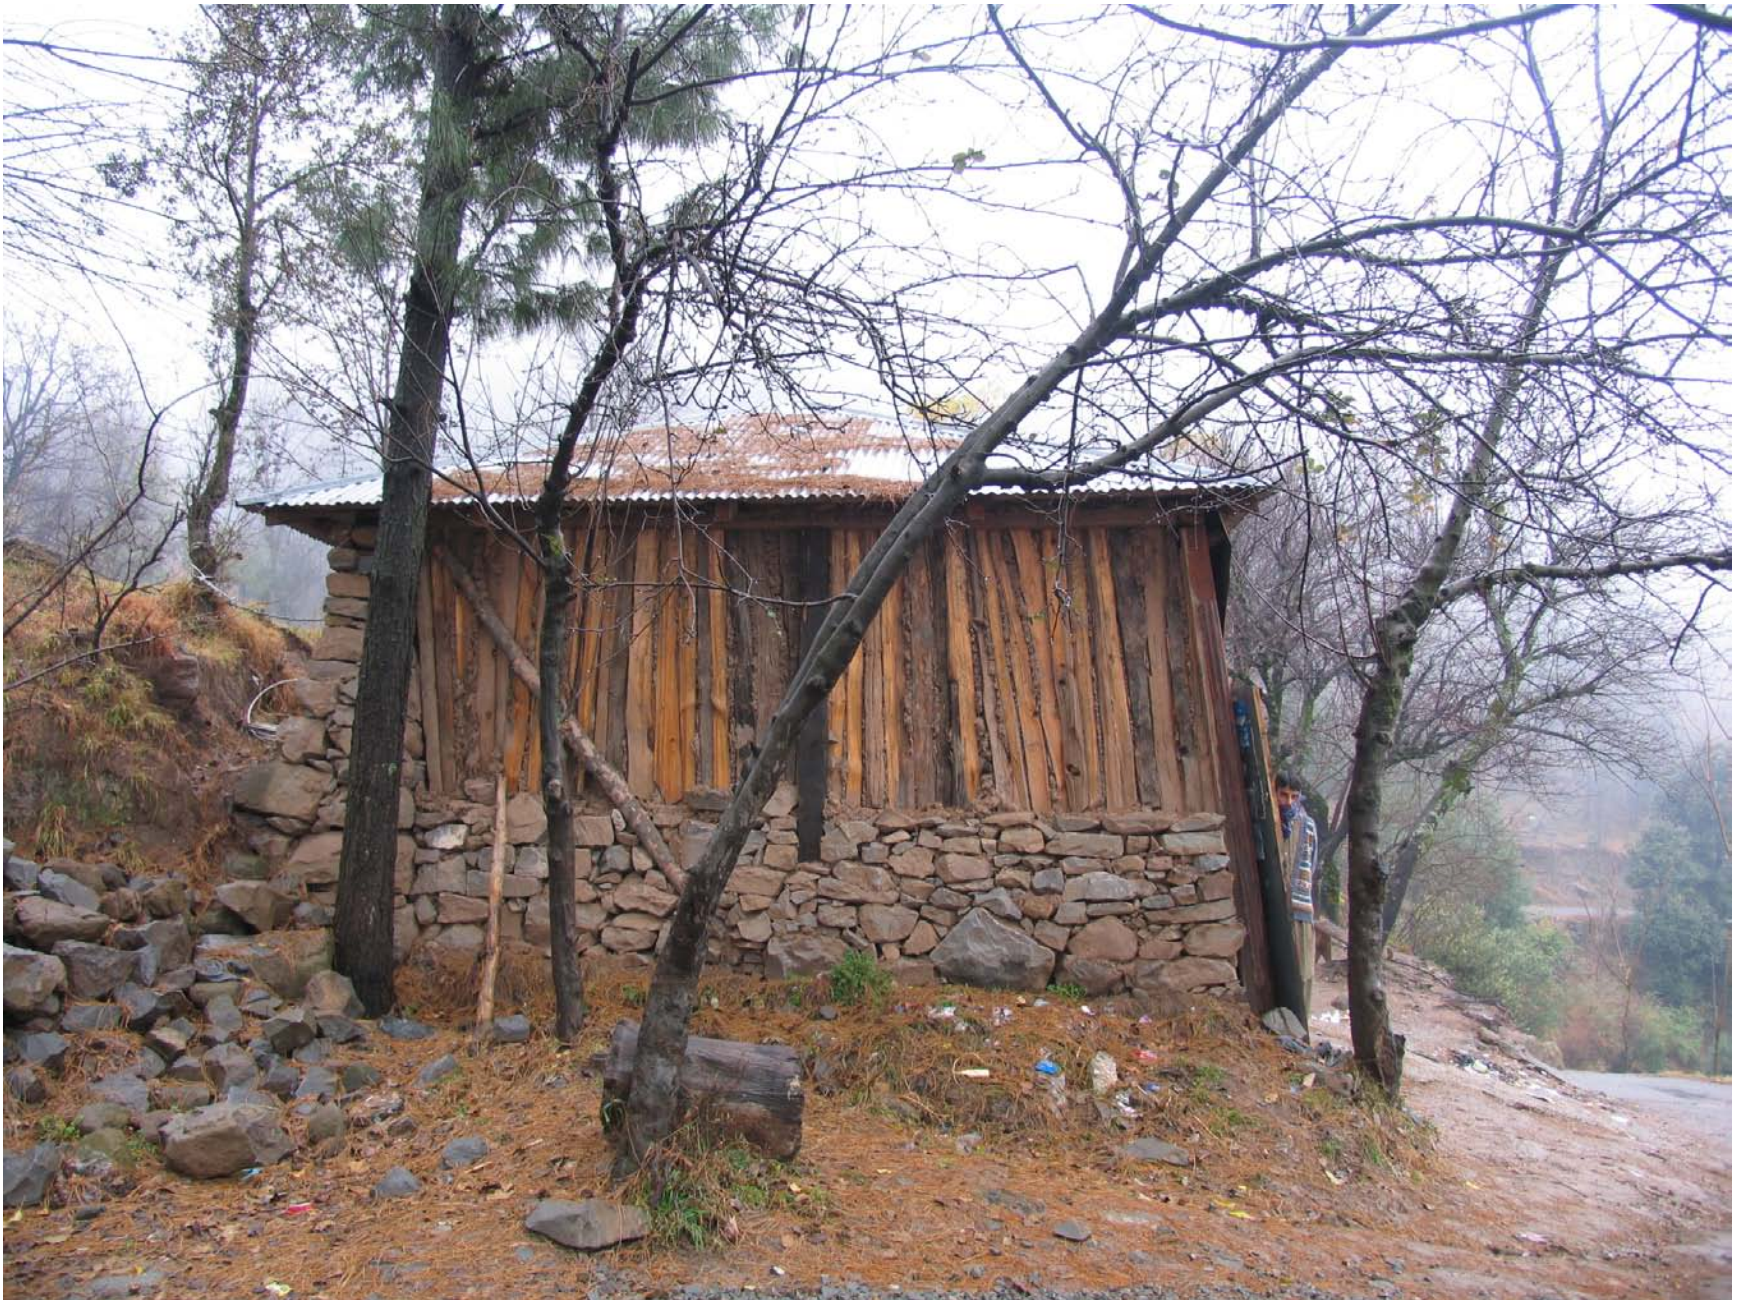
Another building that survived
